FINAL REPORT

IMPACT RESISTANCE OF SPAR-SHELL COMPOSITE FAN BLADES

J. GRAFF, L. STOLTZE AND E. M. VARHOLAK

**HAMILTON STANDARD DIVISION
UNITED AIRCRAFT
WINDSOR LOCKS, CONNECTICUT 06096**

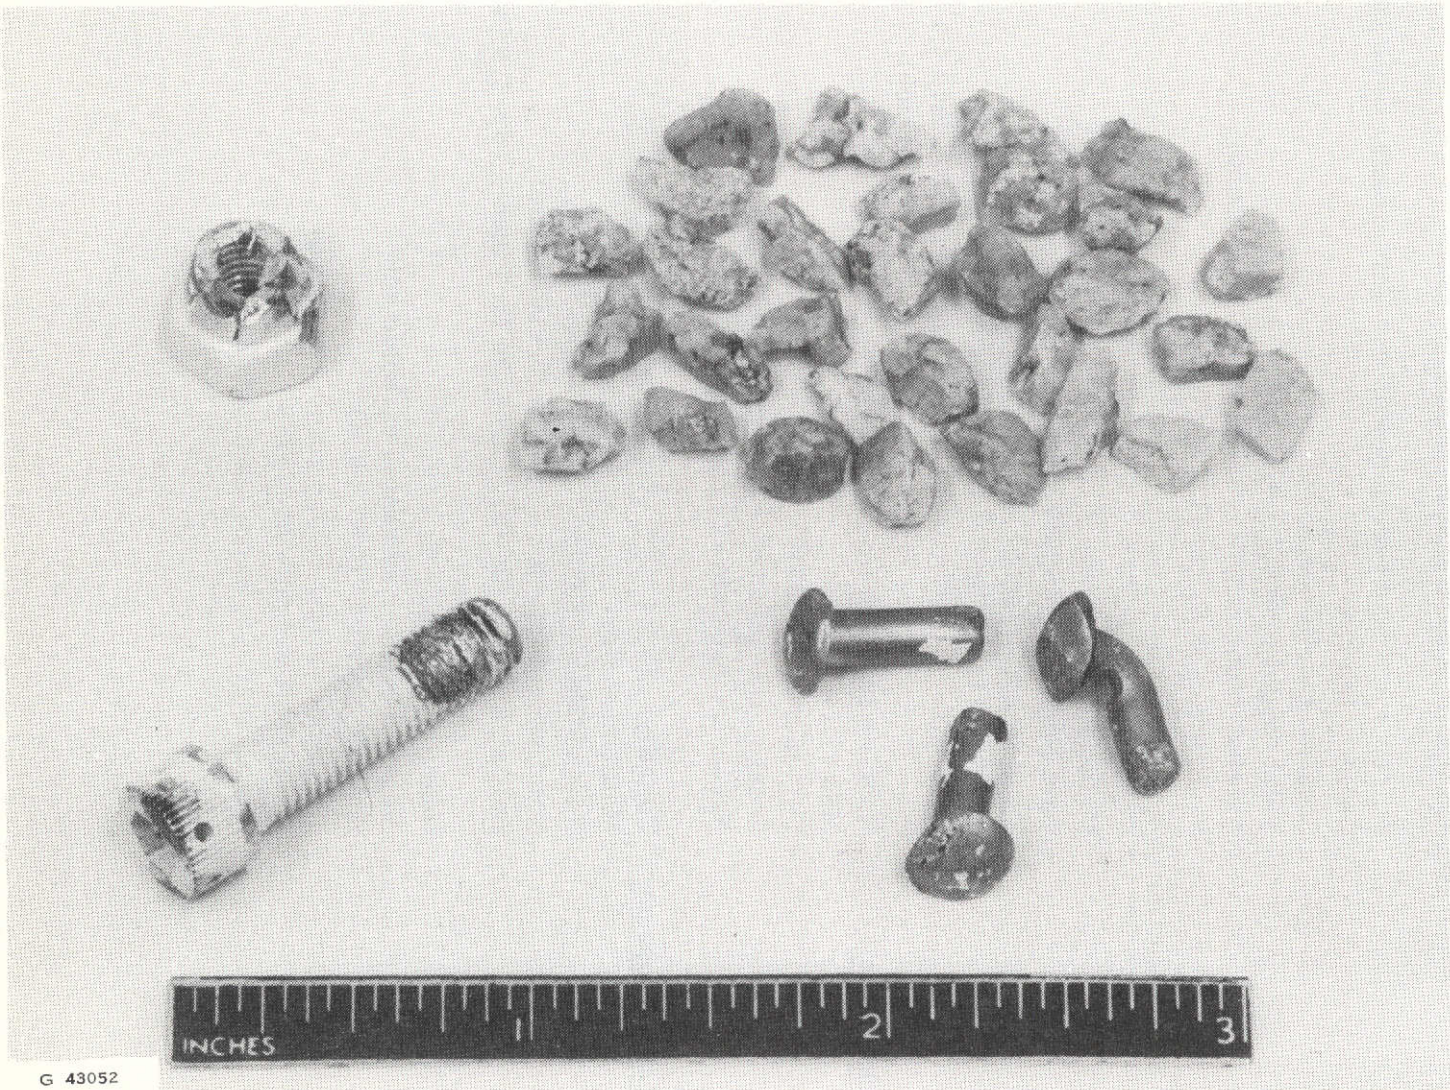
FIGURE 5. SMALL IMPACT MEDIA FOR FOD TESTING

The small impact media used in this program are listed in Table III. The selection of stones, rivets, nuts, bolts and iceballs was made to establish the capability of the blade to resist damage from a variety of typical impact media. The type of stones used in this program had been used at Hamilton Standard in tests on propeller blades, fan blades and blade specimens and was obtained from a lake bed at Edwards Air Force Base in California. As shown in Figure 5, the stones were sharp edged. In tests of blades at Edwards, gouging effects due to stone impact on fiberglass blade surfaces unprotected by the leading edge sheath were severe. The nuts, rivets, and bolts that were impacted, as well as unimpacted stones, are shown in Figure 5. The iceballs used in this program were molded from supersaturated carbonic acid to obtain the 0.80 to 0.85 specific gravity range typical of hail. The fabrication procedure is defined in Appendix B.

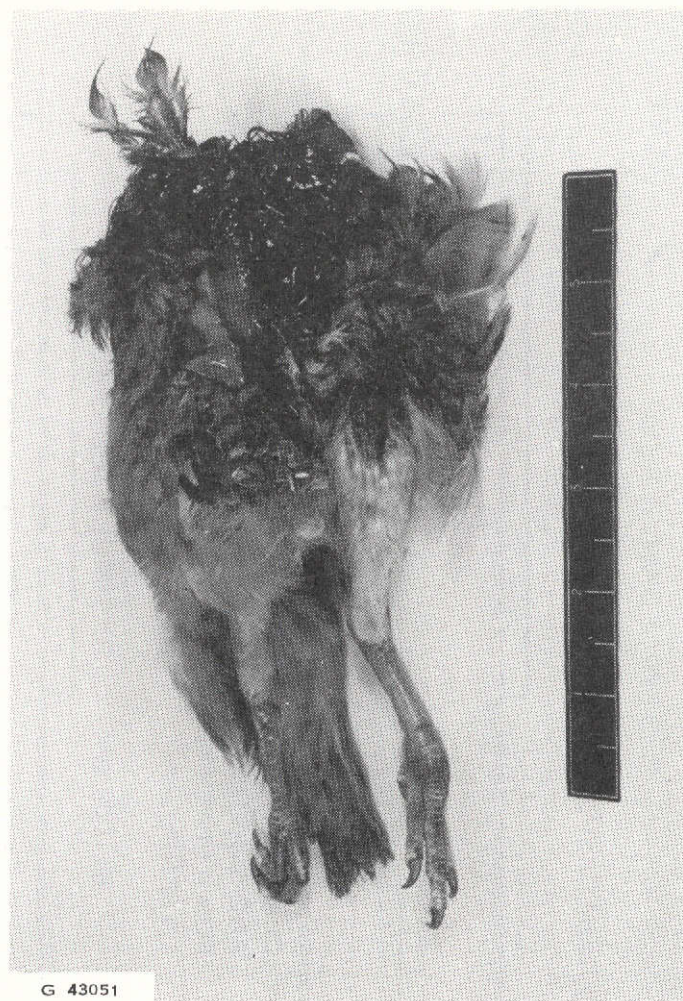
FIGURE 7. CHUKAR PARTRIDGE USED IN FOD TEST

The second large impact media was a real bird. Figure 6C also describes this assembly. The bird was a 499 gram (1.1 pound) chukar partridge (Figure 7) selected for weight on the basis of the results of the simulated bird tests. The frozen bird was thawed overnight prior to use in the test. Aluminum casings and styrofoam were used to mount the bird to the pendulum and to support the partridge. The bird was placed in a nylon bag with head held snugly against the body. The bird was installed for head first injection. The styrofoam casing was sized for a snug fit between bird and foam. The feet were attached by wire to the foam casing.

A) PRE TEST CONDITION
WEIGHT 499 GM (1.1 LB)

B) POST TEST CONDITION
WEIGHT 222 GM (0.50 LB)

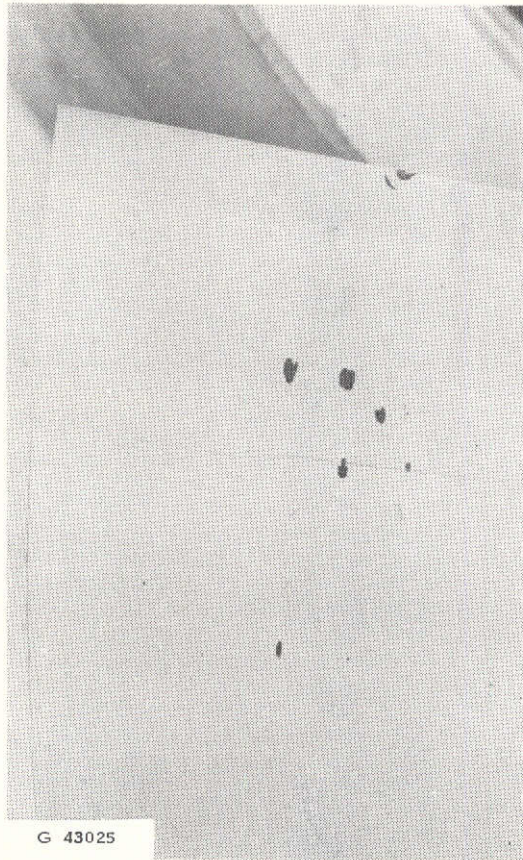
FIGURE 11. RIVET STRIKES - BLADE B-1

1. Stone test - The paint was blemished at the impingement sites. Indentations on the immediate leading edge extended to a depth of 0.005 cm (0.002 inch). Figure 10 shows this blade after the stone impact test run.
2. Rivet test - Paint was removed at the impact sites. Figure 11 shows this blade after the rivet test run.
3. Steel nut test - The strike was on the sheath on the face side of the blade. The depth of the indentation in the sheath was 0.102 cm (0.040 inch). The width was 1.52 cm (0.6 inch). Figure 12A shows the blade after nut impact.
4. Bolt test - The bolt impacted directly on the leading edge. The impact produced an indentation 0.19 cm (0.060 inch) deep and 0.508 cm (0.200 inch) wide. The leading edge was also slightly bent toward the face side, approximately 0.152 cm (0.060 inch). Figure 12B shows the blade after the bolt impact.

A) LEADING EDGE - CAMBER SIDE

B) FACE SIDE - UPPER BLADE

C) FACE SIDE - MID BLADE
